**Flood Control Project Maintenance
Levee Inspections**

Maintenance Issue Types Only, Levee Inspection Report By Mile - Spring 2019

Reclamation District No. 1602 Del Puerto

Waterway	Bank	Unit Miles	Inspection Start/End	Inspector
Unit No. 01 San Joaquin River	Left	6.24	04/16/2019 04/16/2019	Corey Fujitani

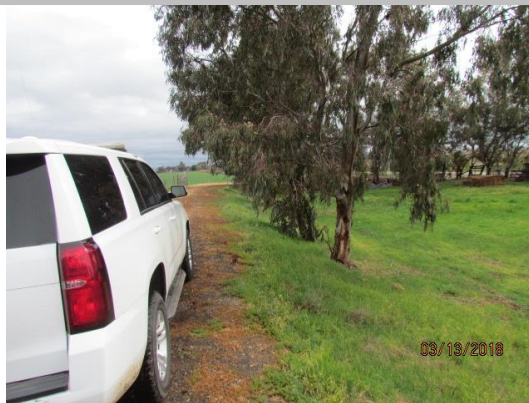
Photo 1 of 1 : SP_2019_RD1602_110_60_20190307_00033.jpg

LM Start	0.09	Rating **	M	Issue No.	60
LM End	0.11	Issue Type +	Ma	Location *	LS
Category	Earthen Levee			GPS Latitude/Longitude	
				Start	End
Item	Trim / Thin Trees			37.477161 °	37.477299 °
				-121.082504 °	-121.082084 °
DWR ID	DWR_RD1602_01_s_2018_60				
Comment Code					
T1 : Trim trees to at least five feet above ground level.					
Inspector Comment

Looking upstream at trees on landward slope.

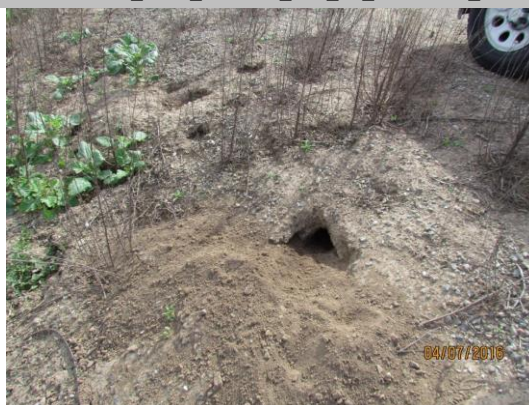
Photo 1 of 2 : SP_2019_RD1602_110_28_20190307_00007.jpg

Updated picture of the rodent hole on the waterside of the levee during spring 2016 inspection.

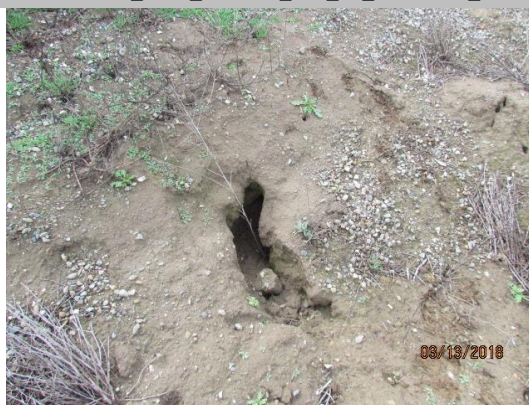
Photo 2 of 2 : SP_2019_RD1602_110_29_20190307_00010.jpg

LM Start	0.26	Rating **	M	Issue No.	29 (cont)
LM End	0.26	Issue Type +	Ma	Location *	WS

Looking at typical rodent holes on waterward slope. (Spring 2018)

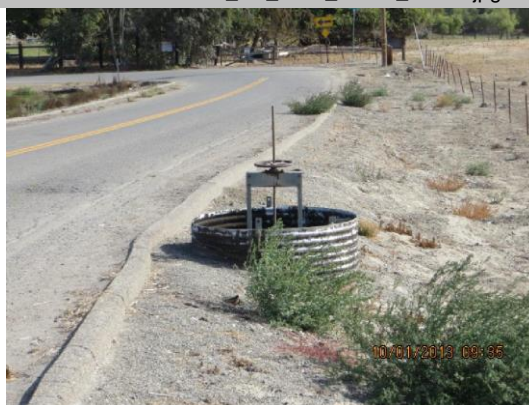
Photo 1 of 3 : UCIP_SP_2019_51325_36702.jpg

Comment Code					
Inspector Comment					
FS_ID:51325 DS_ID:20215 EP_NO: N/A Repair Type: No Action Needed Crossing Status: Found UCIP Comments: 11/18/2016 Crossing has been downgraded from Urgent to No Action Needed a cover has been added to the CMP riser. (O. Magana - DWR UCIP)10/01/2013 Open 60-inch CMP riser on WS needs lid as it's depth may be a hazard to the public. (W. Wylie - DWR UCIP) FIELD_STRUCT_DESC: 16-inch steel drainage pipe through levee, 11.3 feet below crown. Slide gate in 60-inch corrugated metal pipe (CMP) riser located on the waterside (WS). Concrete inlet is approximately 110 feet west of the levee crown or 110 feet off landside (LS) toe next to roadway. [Additional Reference(s): DWR Levee Log, 1992. USACE San Joaquin River O&M Manual Unit 13, April 1964, (HLM 0.58), Drawing No. 7-4-1784]. FS Date: 11/18/2016

60-inch CMP riser on WS shoulder.

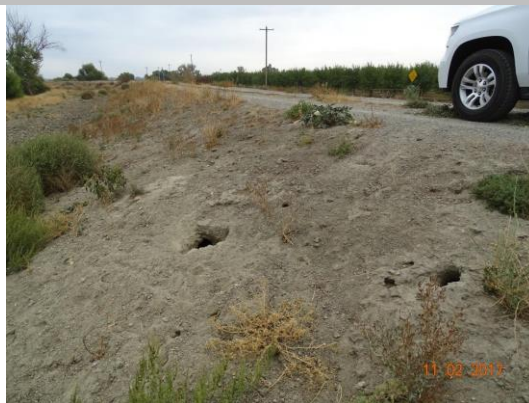
Photo 1 of 1 : SP_2019_RD1602_110_30_20190307_00011.jpg

View of rodent holes on the waterside slope of the levee. Fall 2017

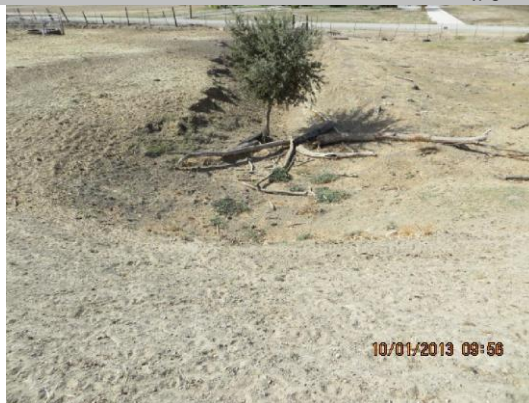
Photo 1 of 3 : UCIP_SP_2019_51634_36723.jpg

Comment Code					
Inspector Comment					
FS_ID:51634 DS_ID:20216 EP_NO: N/A Repair Type: No Action Needed Crossing Status: Found UCIP Comments: 11/18/2016 Crossing has been downgraded from Urgent to No Action Needed the debris blocking the outlet has been cleared. (O. Magana - DWR UCIP)10/01/2013 Flap gate blocked from functioning by soil buildup on WS toe. Soil should be cleared. (W. Wylie - DWR UCIP) FIELD_STRUCT_DESC: 30-inch square reinforced concrete box culvert through levee, 14.4 feet below crown. Concrete "U" headwall on the waterside (WS) and landside (LS) ends. Slide gate in 6-foot by 7-foot concrete surge box is located on the WS shoulder. Flap gate is located on the WS end. [Additional Reference(s): DWR Levee Log, 1992. USACE San Joaquin River O&M Manual Unit 13, April 1964, (HLM 0.78), Drawing No. 7-4-1784]. FS Date: 11/18/2016

Inlet on LS toe.

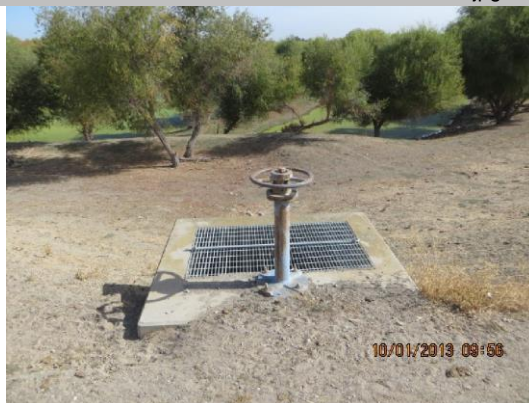
Photo 2 of 3 : UCIP_SP_2019_51634_36722.jpg

Slide gate in concrete box on WS shoulder.

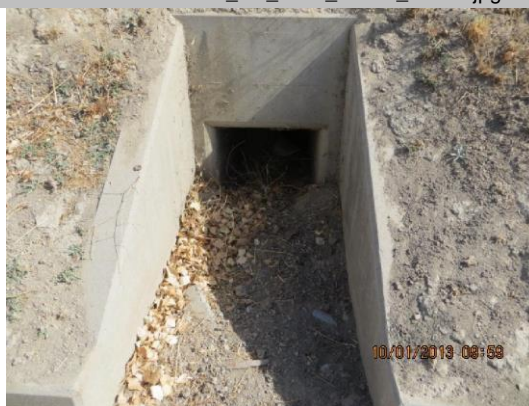
Photo 3 of 3 : UCIP_SP_2019_51634_36721.jpg

Item	DWR UCIP LMA Responsibility			37.477993 °	37.477993 °	
				-121.072645 °	-121.072645 °	
DWR ID	20216					
Comment Code						
Inspector Comment						
FS_ID:51634 DS_ID:20216 EP_NO: N/A Repair Type: No Action Needed Crossing Status: Found UCIP Comments: 11/18/2016 Crossing has been downgraded from Urgent to No Action Needed the debris blocking the outlet has been cleared. (O. Magana - DWR UCIP)10/01/2013 Flap gate blocked from functioning by soil buildup on WS toe. Soil should be cleared. (W. Wylie - DWR UCIP) FIELD_STRUCT_DESC: 30-inch square reinforced concrete box culvert through levee, 14.4 feet below crown. Concrete "U" headwall on the waterside (WS) and landside (LS) ends. Slide gate in 6-foot by 7-foot concrete surge box is located on the WS shoulder. Flap gate is located on the WS end. [Additional Reference(s): DWR Levee Log, 1992. USACE San Joaquin River O&M Manual Unit 13, April 1964, (HLM 0.78), Drawing No. 7-4-1784]. FS Date: 11/18/2016

Concrete inlet on LS toe.

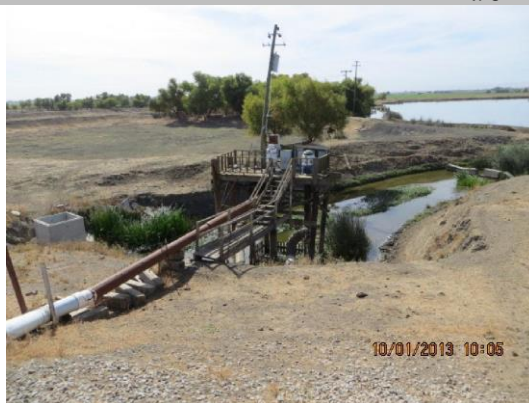
Photo 1 of 3 : UCIP_SP_2019_51636_36758.jpg

Comment Code					
Inspector Comment					
FS_ID:51636 DS_ID:20217 EP_NO: N/A Repair Type: Non-Urgent Crossing Status: Found UCIP Comments: 11/18/2016 Crossing has been downgraded from Urgent to Non-Urgent a flap gate has been added to the WS but pipe is currently not connected to pump. According to Tony Martinez, LMA representative, this crossing is currently not in use. Owner will need to coordinate with CVFPB to obtain permit. (O. Magana - DWR UCIP)10/01/2013 Appears abandoned and if so should be done so properly. Flapgate missing. (W. Wylie - DWR UCIP) FIELD_STRUCT_DESC: *ABANDONED* 1 of 2: 16-inch steel drainage pipe through levee, 17 feet below crown. Pumps on the pump platform are located on the landside (LS). Siphon breaker in 24-inch corrugated metal pipe (CMP) riser is located on the waterside (WS) shoulder. Concrete "U" headwall and flap gate are located on the WS end. [Additional Reference(s): DWR Levee Log, 1992. USACE San Joaquin River O&M Manual Unit 13, April 1964, (HLM 1.01), Drawing No. 7-4-1784]. FS Date: 11/18/2016

Pumping plant on LS toe. Pipe visible under walkway.

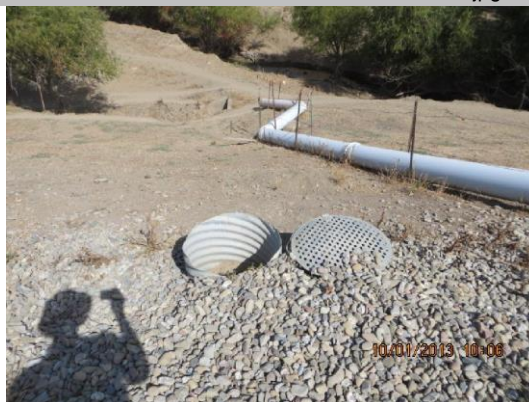
Photo 2 of 3 : UCIP_SP_2019_51636_36757.jpg

Siphon breaker in 24-inch CMP riser on WS shoulder.

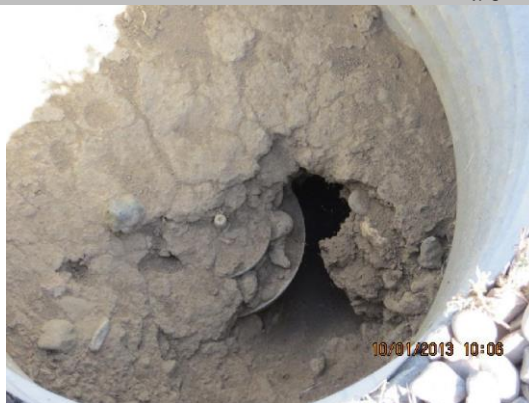
Photo 3 of 3 : UCIP_SP_2019_51636_36756.jpg

Comment Code						
Inspector Comment						
FS_ID:51636 DS_ID:20217 EP_NO: N/A Repair Type: Non-Urgent Crossing Status: Found UCIP Comments: 11/18/2016 Crossing has been downgraded from Urgent to Non-Urgent a flap gate has been added to the WS but pipe is currently not connected to pump. According to Tony Martinez, LMA representative, this crossing is currently not in use. Owner will need to coordinate with CVFPB to obtain permit. (O. Magana - DWR UCIP)10/01/2013 Appears abandoned and if so should be done so properly. Flapgate missing. (W. Wylie - DWR UCIP) FIELD_STRUCT_DESC: *ABANDONED* 1 of 2: 16-inch steel drainage pipe through levee, 17 feet below crown. Pumps on the pump platform are located on the landside (LS). Siphon breaker in 24-inch corrugated metal pipe (CMP) riser is located on the waterside (WS) shoulder. Concrete "U" headwall and flap gate are located on the WS end. [Additional Reference(s): DWR Levee Log, 1992. USACE San Joaquin River O&M Manual Unit 13, April 1964, (HLM 1.01), Drawing No. 7-4-1784]. FS Date: 11/18/2016

Siphon breaker in 24-inch CMP riser on WS shoulder.

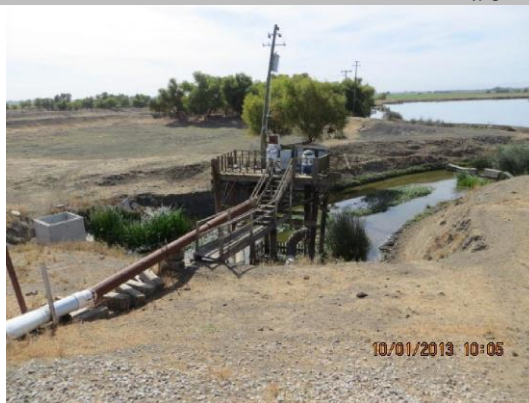
Photo 1 of 3 : UCIP_SP_2019_51637_36772.jpg

Comment Code					
Inspector Comment					
FS_ID:51637 DS_ID:20219 EP_NO: N/A Repair Type: Non-Urgent Crossing Status: Found UCIP Comments: 11/18/2016 Crossing has been downgraded from Urgent to Non-Urgent a flap gate has been added to the WS. According to Tony Martinez, LMA representative, this crossing is currently not in use. Owner will need to coordinate with CVFPB to obtain permit. (O. Magana - DWR UCIP)10/01/2013 Appears abandoned siphon breakers covered in soil and flapgate missing. (W. Wylie - DWR UCIP) FIELD_STRUCT_DESC: *ABANDONED* 2 of 2: 16-inch steel drainage pipe through levee, 17 feet below crown. Pump on pump platform located on the landside (LS). Siphon breaker in 24-inch riser located on the waterside (WS) shoulder. Concrete "U" headwall and flap gate are located on the WS end. [Additional Reference(s): DWR Levee Log, 1992. USACE San Joaquin River O&M Manual Unit 13, April 1964, (HLM 1.01), Drawing No. 7-4-1784]. FS Date: 11/18/2016

Pipe visible under walkway at puming plant on LS toe.

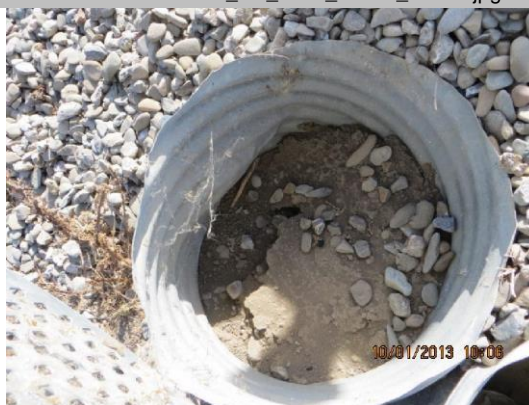
Photo 2 of 3 : UCIP_SP_2019_51637_36771.jpg

Siphon breaker covered in soil at CMP riser on WS shoulder.

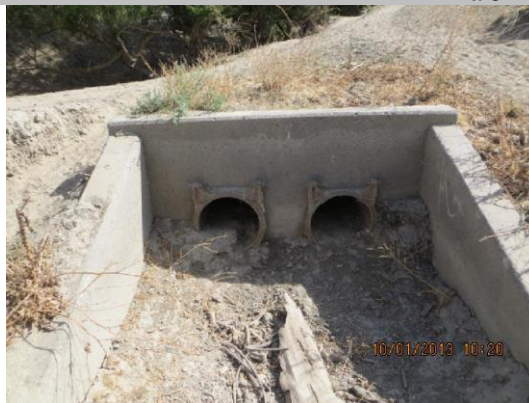
Photo 3 of 3 : UCIP_SP_2019_51637_36770.jpg

Comment Code						
Inspector Comment						
FS_ID:51637 DS_ID:20219 EP_NO: N/A Repair Type: Non-Urgent Crossing Status: Found UCIP Comments: 11/18/2016 Crossing has been downgraded from Urgent to Non-Urgent a flap gate has been added to the WS. According to Tony Martinez, LMA representative, this crossing is currently not in use. Owner will need to coordinate with CVFPB to obtain permit. (O. Magana - DWR UCIP)10/01/2013 Appears abandoned siphon breakers covered in soil and flapgate missing. (W. Wylie - DWR UCIP) FIELD_STRUCT_DESC: *ABANDONED* 2 of 2: 16-inch steel drainage pipe through levee, 17 feet below crown. Pump on pump platform located on the landside (LS). Siphon breaker in 24-inch riser located on the waterside (WS) shoulder. Concrete "U" headwall and flap gate are located on the WS end. [Additional Reference(s): DWR Levee Log, 1992. USACE San Joaquin River O&M Manual Unit 13, April 1964, (HLM 1.01), Drawing No. 7-4-1784]. FS Date: 11/18/2016

Concrete headwall on WS toe with missing flapgate.

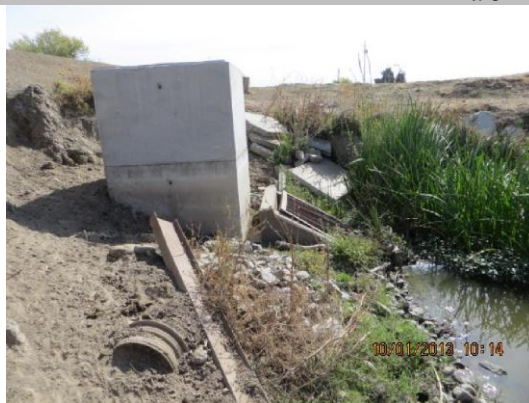
Photo 1 of 3 : UCIP_SP_2019_53521_36786.jpg

UCIP Comments: 10/19/2018 Pipe remains the same. WS concrete headwall is still detached with vertical erosion on the WS slope. Dense vegetation along pipe alignment made it difficult to inspect levee slopes and identify any potential issues present at this site. Recommend clearing vegetation along pipe alignment to be able to conduct a proper UCIP inspection. This crossing is part of DWR's Flood System Repair Project (FSRP) and Deferred Maintenance Project (DMP). Crossing will be monitored to identify progress of erosion on the WS slope. Crossing remains Urgent due to the detachment of the concrete wall and vertical cut on the WS. (O. Magana - DWR UCIP)11/18/2016 Same as previous inspection headwall on the WS toe has separated from pipe and flap gate is still missing. Erosion around concrete headwall and undermined WS slope are visible from WS. The slope undermined appears to have progressed but no photos were taken due to the dense vegetation covering area. According to Tony Martinez, LMA representative, the WS concrete headwall has been detached since 2008/2009. LMA has been in contact with CVFPB, DWR, and USACE regarding this site. (O. Magana - DWR UCIP)10/01/2013 Headwall on WS toe separated from pipe. Erosion around concrete headwall and undermined at WS toe. Flap gate missing from WS toe headwall. (W. Wylie - DWR UCIP)

Grated inlet and 5'X5' concrete box on LS toe.

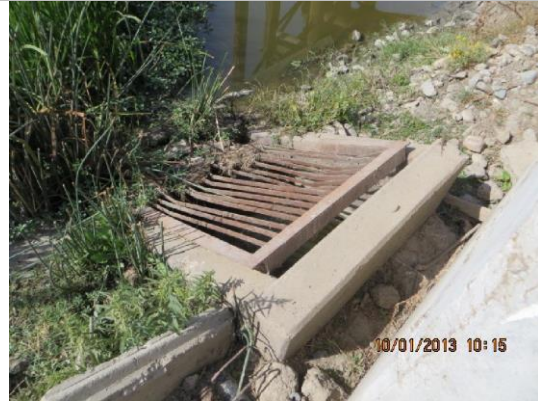
Photo 2 of 3 : UCIP_SP_2019_53521_36785.jpg

FS_ID:53521
DS_ID:20218
EP_NO: N/A
Repair Type: Urgent
Crossing Status: Found
UCIP Comments: 10/19/2018 Pipe remains the same. WS concrete headwall is still detached with vertical erosion on the WS slope. Dense vegetation along pipe alignment made it difficult to inspect levee slopes and identify any potential issues present at this site. Recommend clearing vegetation along pipe alignment to be able to conduct a proper UCIP inspection. This crossing is part of DWR's Flood System Repair Project (FSRP) and Deferred Maintenance Project (DMP). Crossing will be monitored to identify progress of erosion on the WS slope. Crossing remains Urgent due to the detachment of the concrete wall and vertical cut on the WS. (O. Magana - DWR UCIP)11/18/2016 Same as previous inspection headwall on the WS toe has separated from pipe and flap gate is still missing. Erosion around concrete headwall and undermined WS slope are visible from WS. The slope undermined appears to have progressed but no photos were taken due to the dense vegetation covering area. According to Tony Martinez, LMA representative, the WS concrete headwall has been detached since 2008/2009. LMA has been in contact with CVFPB, DWR, and USACE regarding this site. (O. Magana - DWR UCIP)10/01/2013 Headwall on WS toe separated from pipe. Erosion around concrete headwall and undermined at WS toe. Flap gate missing from WS toe headwall. (W. Wylie - DWR UCIP)

Grated inlet at LS toe.

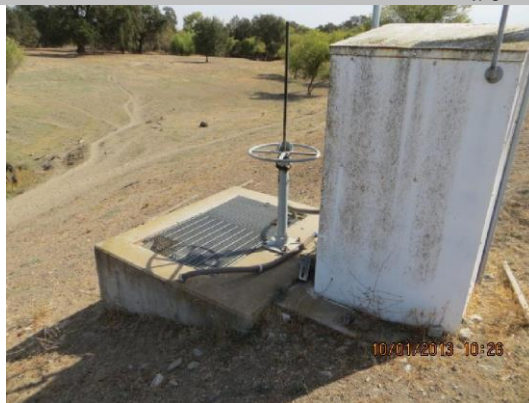
Photo 3 of 3 : UCIP_SP_2019_53521_36789.jpg

UCIP Comments: 10/19/2018 Pipe remains the same. WS concrete headwall is still detached with vertical erosion on the WS slope. Dense vegetation along pipe alignment made it difficult to inspect levee slopes and identify any potential issues present at this site. Recommend clearing vegetation along pipe alignment to be able to conduct a proper UCIP inspection. This crossing is part of DWR's Flood System Repair Project (FSRP) and Deferred Maintenance Project (DMP). Crossing will be monitored to identify progress of erosion on the WS slope. Crossing remains Urgent due to the detachment of the concrete wall and vertical cut on the WS. (O. Magana - DWR UCIP)11/18/2016 Same as previous inspection headwall on the WS toe has separated from pipe and flap gate is still missing. Erosion around concrete headwall and undermined WS slope are visible from WS. The slope undermined appears to have progressed but no photos were taken due to the dense vegetation covering area. According to Tony Martinez, LMA representative, the WS concrete headwall has been detached since 2008/2009. LMA has been in contact with CVFPB, DWR, and USACE regarding this site. (O. Magana - DWR UCIP)10/01/2013 Headwall on WS toe separated from pipe. Erosion around concrete headwall and undermined at WS toe. Flap gate missing from WS toe headwall. (W. Wylie - DWR UCIP)

Slide gate in concrete riser next to shed on WS shoulder.

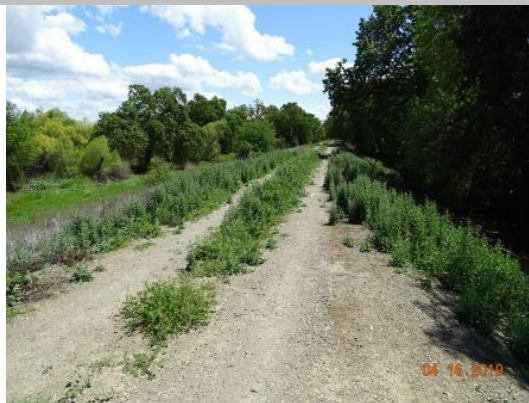
Photo 1 of 1 : SP_2019_RD1602_110_120_20190424_00112.jpg

View of vegetation on crown looking upstream. (Spring 2019)

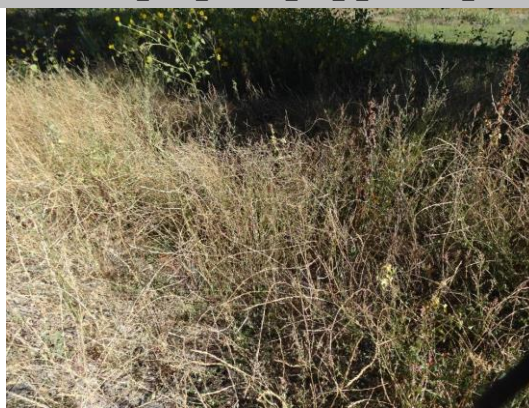
Photo 1 of 4 : SP_2019_RD1602_110_2_20190307_00001.jpg

LM Start	1.05	Rating **	M	Issue No.	2
LM End	1.05	Issue Type +	Ma	Location *	WS
Category	Supplemental			GPS Latitude/Longitude	
				Start	End
Item	DWR Erosion Survey			37.478567 °	37.478567 °
				-121.067847 °	-121.067847 °
DWR ID	RD1602U01RM97.68				
Comment Code					
Inspector Comment					
09/20/2017: The erosion was discovered during the spring levee inspection. The size of the erosion is roughly estimated due to dense vegetation at the site. [2017 Site ID:RD1602U01RM97.68]

Close view of the erosion. The erosion is covered by dense vegetation at the site.

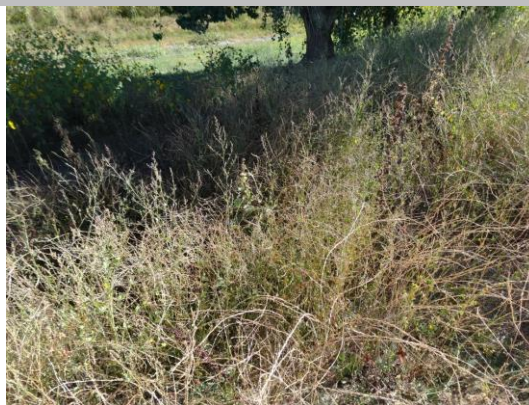
Photo 2 of 4 : SP_2019_RD1602_110_2_20190307_00002.jpg

Close view of the erosion.

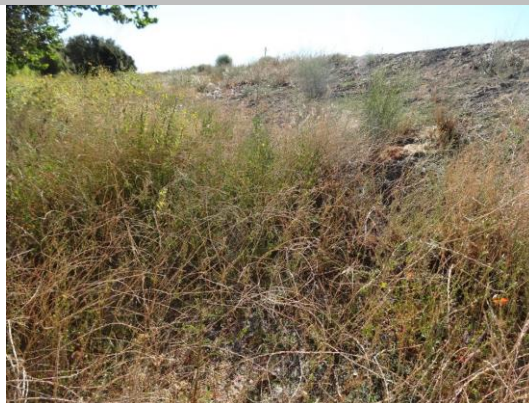
Photo 3 of 4 : SP_2019_RD1602_110_2_20190307_00003.jpg

Looking up at the erosion from the levee toe.

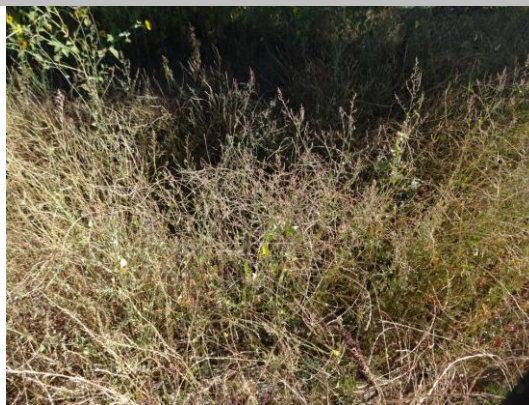
Photo 4 of 4 : SP_2019_RD1602_110_2_20190307_00004.jpg

Close view of the erosion.

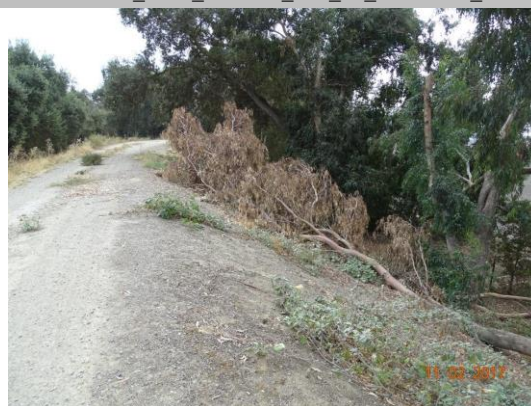
Photo 1 of 1 : SP_2019_RD1602_110_33_20190307_00012.jpg

View of prunings on the landside of the levee.

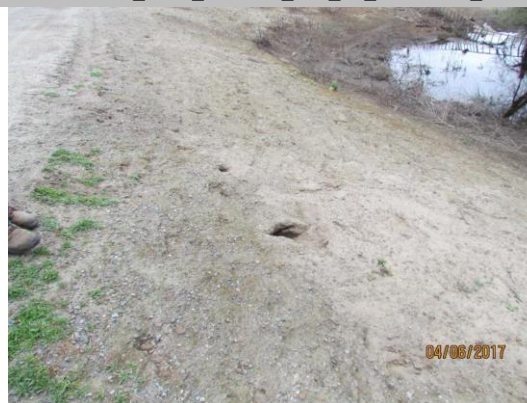
Photo 1 of 1 : SP_2019_RD1602_110_81_20190307_00049.jpg

View of a rodent hole on the waterside slope of the levee.

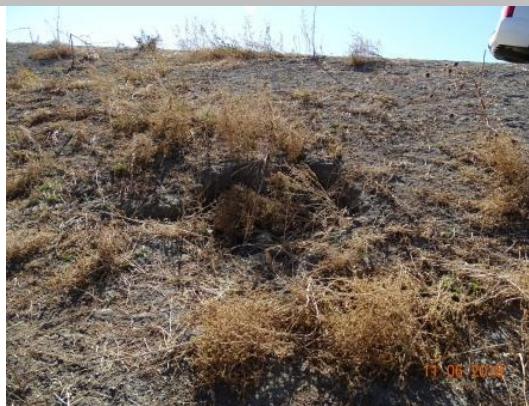
Photo 1 of 2 : SP_2019_RD1602_110_98_20190307_00061.jpg

erosion at waterside toe. (Fall 2018)

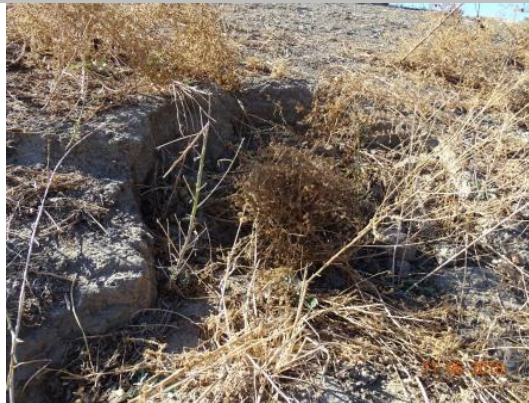
Photo 2 of 2 : SP_2019_RD1602_110_98_20190307_00062.jpg

close up view of erosion at toe. (Fall 2018)

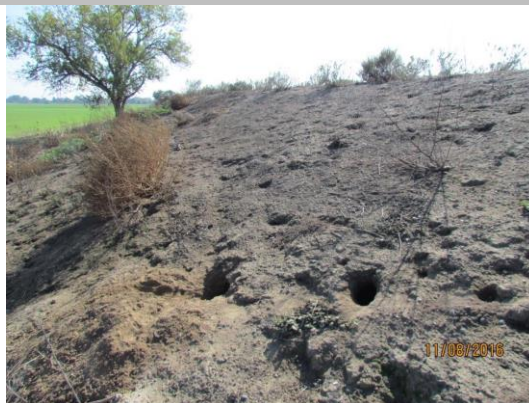
Photo 1 of 1 : SP_2019_RD1602_110_47_20190307_00023.jpg

View of rodent holes on the waterside of the levee. Fall 2016

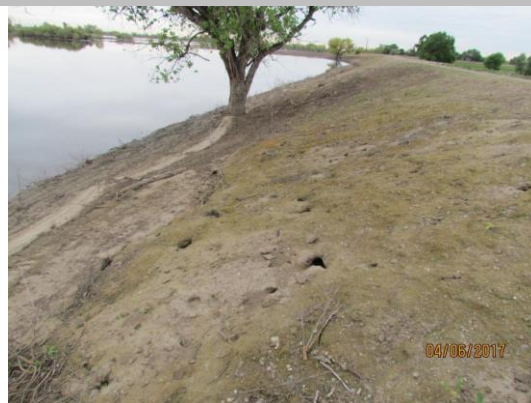
Photo 1 of 1 : SP_2019_RD1602_110_49_20190307_00025.jpg

View of rodent holes on the waterside slope of the levee. Spring 2017

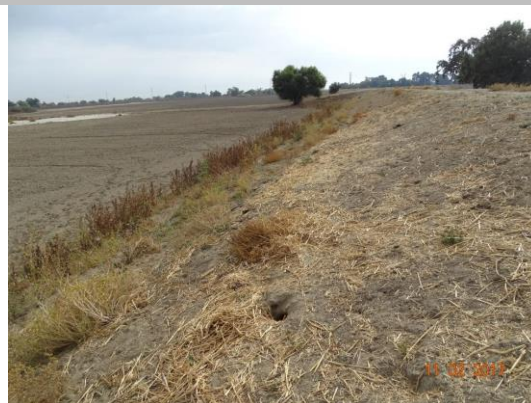
Photo 1 of 1 : SP_2019_RD1602_110_51_20190307_00027.jpg

View of a rodent hole on the waterside of the levee.

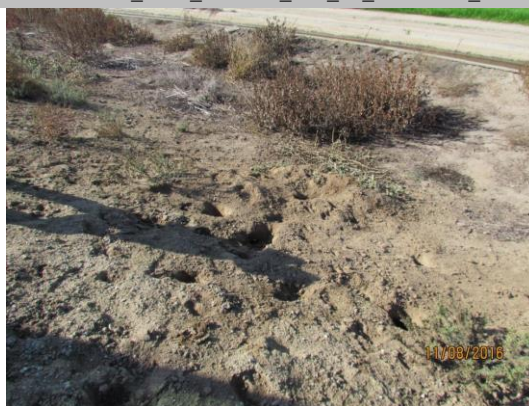
Photo 1 of 1 : SP_2019_RD1602_110_56_20190307_00030.jpg

View of rodent holes on the landside of the levee. Fall 2016

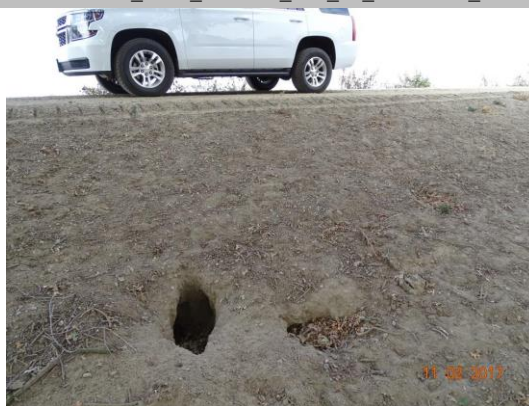
Photo 1 of 1 : SP_2019_RD1602_110_57_20190307_00031.jpg

View of a rodent hole on the waterside of the levee.

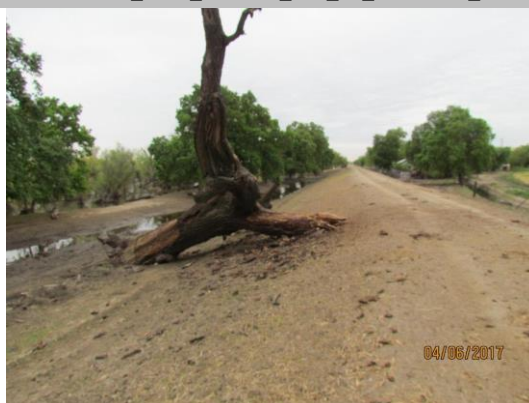
Photo 1 of 1 : SP_2019_RD1602_110_83_20190307_00053.jpg

View of a tree trunk on the waterside slope of the levee.

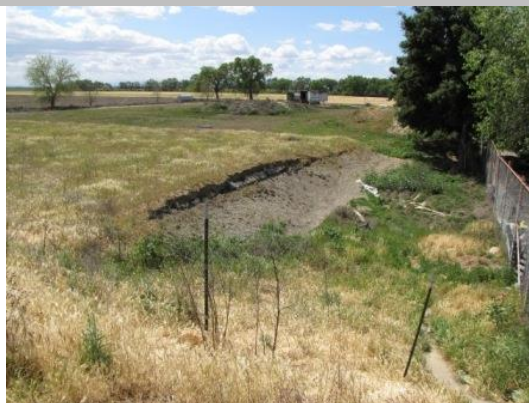
Photo 1 of 1 : SP_2019_RD1602_110_62_20190307_00036.jpg

LM Start	3.93	Rating **	M	Issue No.	62
LM End	3.93	Issue Type +	Ma	Location *	LS
Category	Earthen Levee			GPS Latitude/Longitude	
				Start	End
Item	Slope Stability			37.453216 °	37.453216 °
				-121.042127 °	-121.042127 °
DWR ID	DWR_RD1602_01_s_2012_62				
Comment Code					
S3 : Repair the levee slope damaged by vehicle traffic and prevent access where possible.					
Inspector Comment					
Significant damage to USACE constructed seepage berm due to human activity.

Repair damage to USACE constructed seepage berm by pedestrian and cycle traffic.

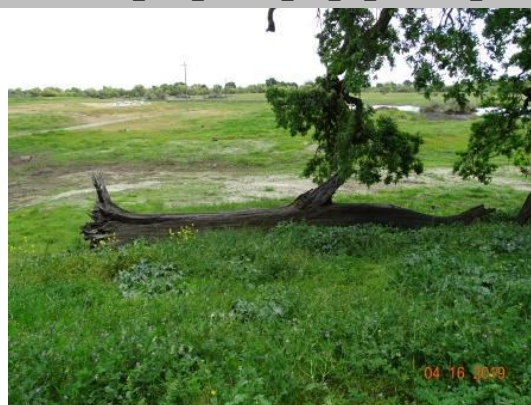
Photo 1 of 1 : SP_2019_RD1602_110_69_20190515_00119.jpg

View of fallen tree trunk on waterside slope. (Spring 2019)

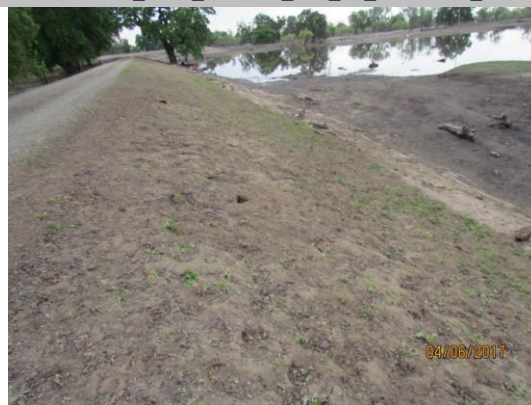
Photo 1 of 1 : SP_2019_RD1602_110_91_20190307_00058.jpg

View of rodent holes on the waterside of the levee looking downstream. Spring 2017

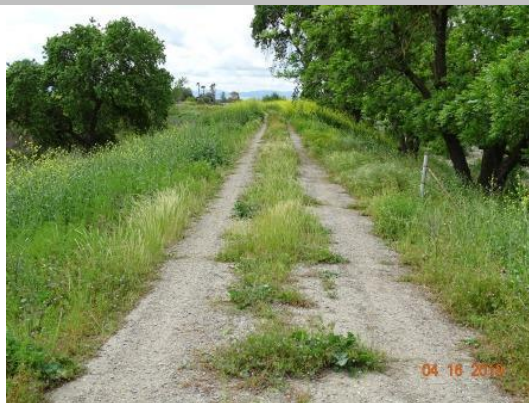
Photo 1 of 1 : SP_2019_RD1602_110_25_20190424_00115.jpg

View of vegetation on levee crown looking downstream. (Spring 2019)

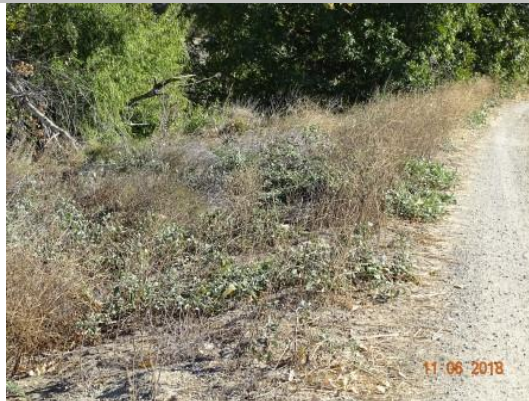
Photo 2 of 3 : SP_2019_RD1602_110_75_20190307_00045.jpg

dense vegetation on waterside slope. (Fall 2018)

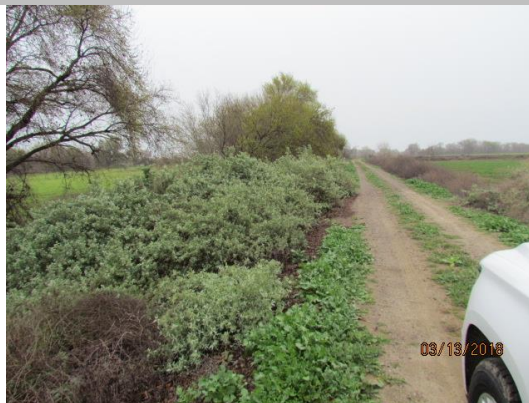
Photo 3 of 3 : SP_2019_RD1602_110_75_20190307_00046.jpg

Looking at upstream at dense vegetation on waterward slope. (Spring 2018)

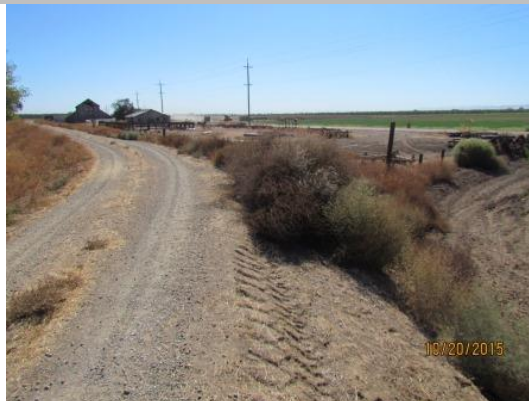
Photo 2 of 2 : SP_2019_RD1602_110_61_20190307_00035.jpg

Vegetation was obstructing the view of the landside of the levee.

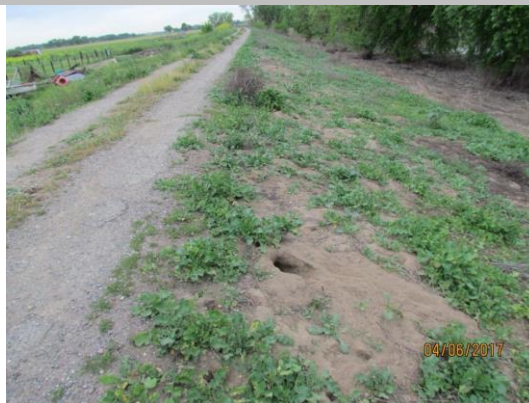
Photo 1 of 1 : SP_2019_RD1602_110_92_20190307_00059.jpg

View of a rodent hole on the waterside shoulder of the levee looking downstream.

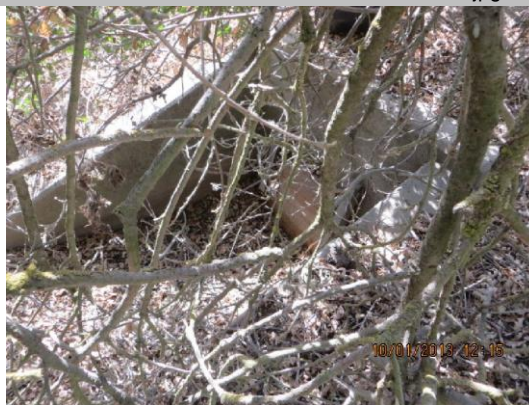
Photo 2 of 3 : UCIP_SP_2019_51336_36821.jpg

Flapgate in Concrete headwall on WS toe under tree.

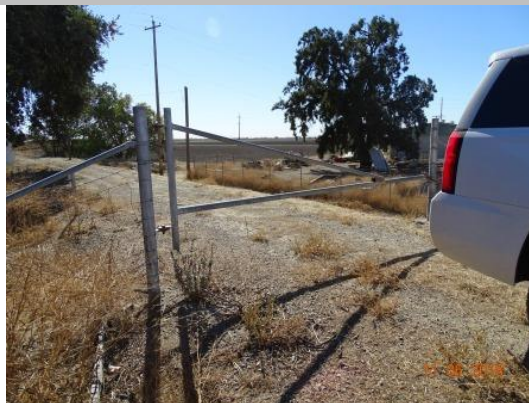
Photo 1 of 1 : SP_2019_RD1602_110_40_20190307_00018.jpg

DWR and LMA do not have keys for locks on gate. (Fall 2018)

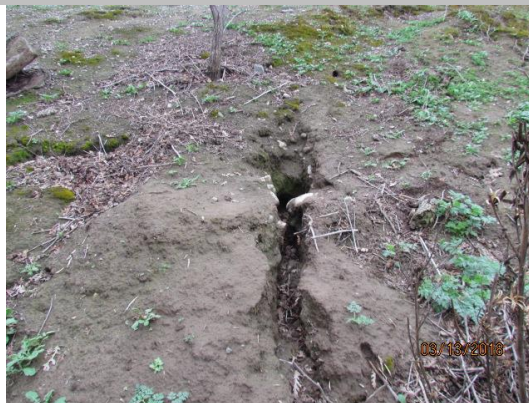
Photo 1 of 1 : SP_2019_RD1602_110_52_20190307_00028.jpg

Looking at rodent hole and erosion around rodent hole on waterward slope.

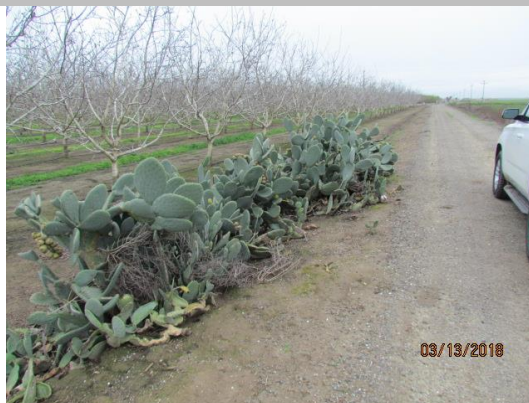
Photo 1 of 1 : SP_2019_RD1602_110_86_20190307_00055.jpg

Looking south at dense cactus on waterward slope.

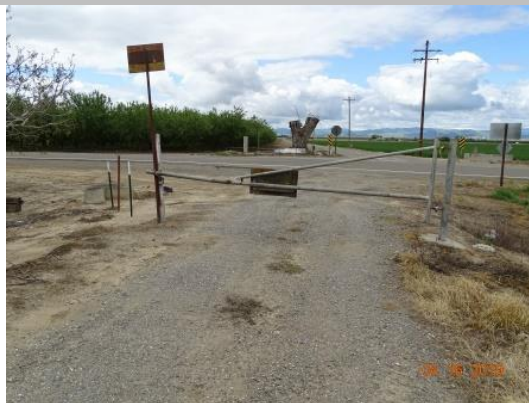
Photo 1 of 1 : SP_2019_RD1602_110_19_20190424_00118.jpg

Landowner replaced existing LMA lock with their own lock. Unable to access through the gate.
